**TSCA IMPLEMENTATION REPORT  
FORMER STEARNS AND FOSTER PROPERTY  
200 SHEPHERD AVENUE  
LOCKLAND, HAMILTON COUNTY, OHIO**

*PREPARED FOR:*  
**HAMILTON COUNTY OHIO  
B.A.D. Properties**

**JANUARY 7, 2013  
SME PROJECT NUMBER: 064310.00**

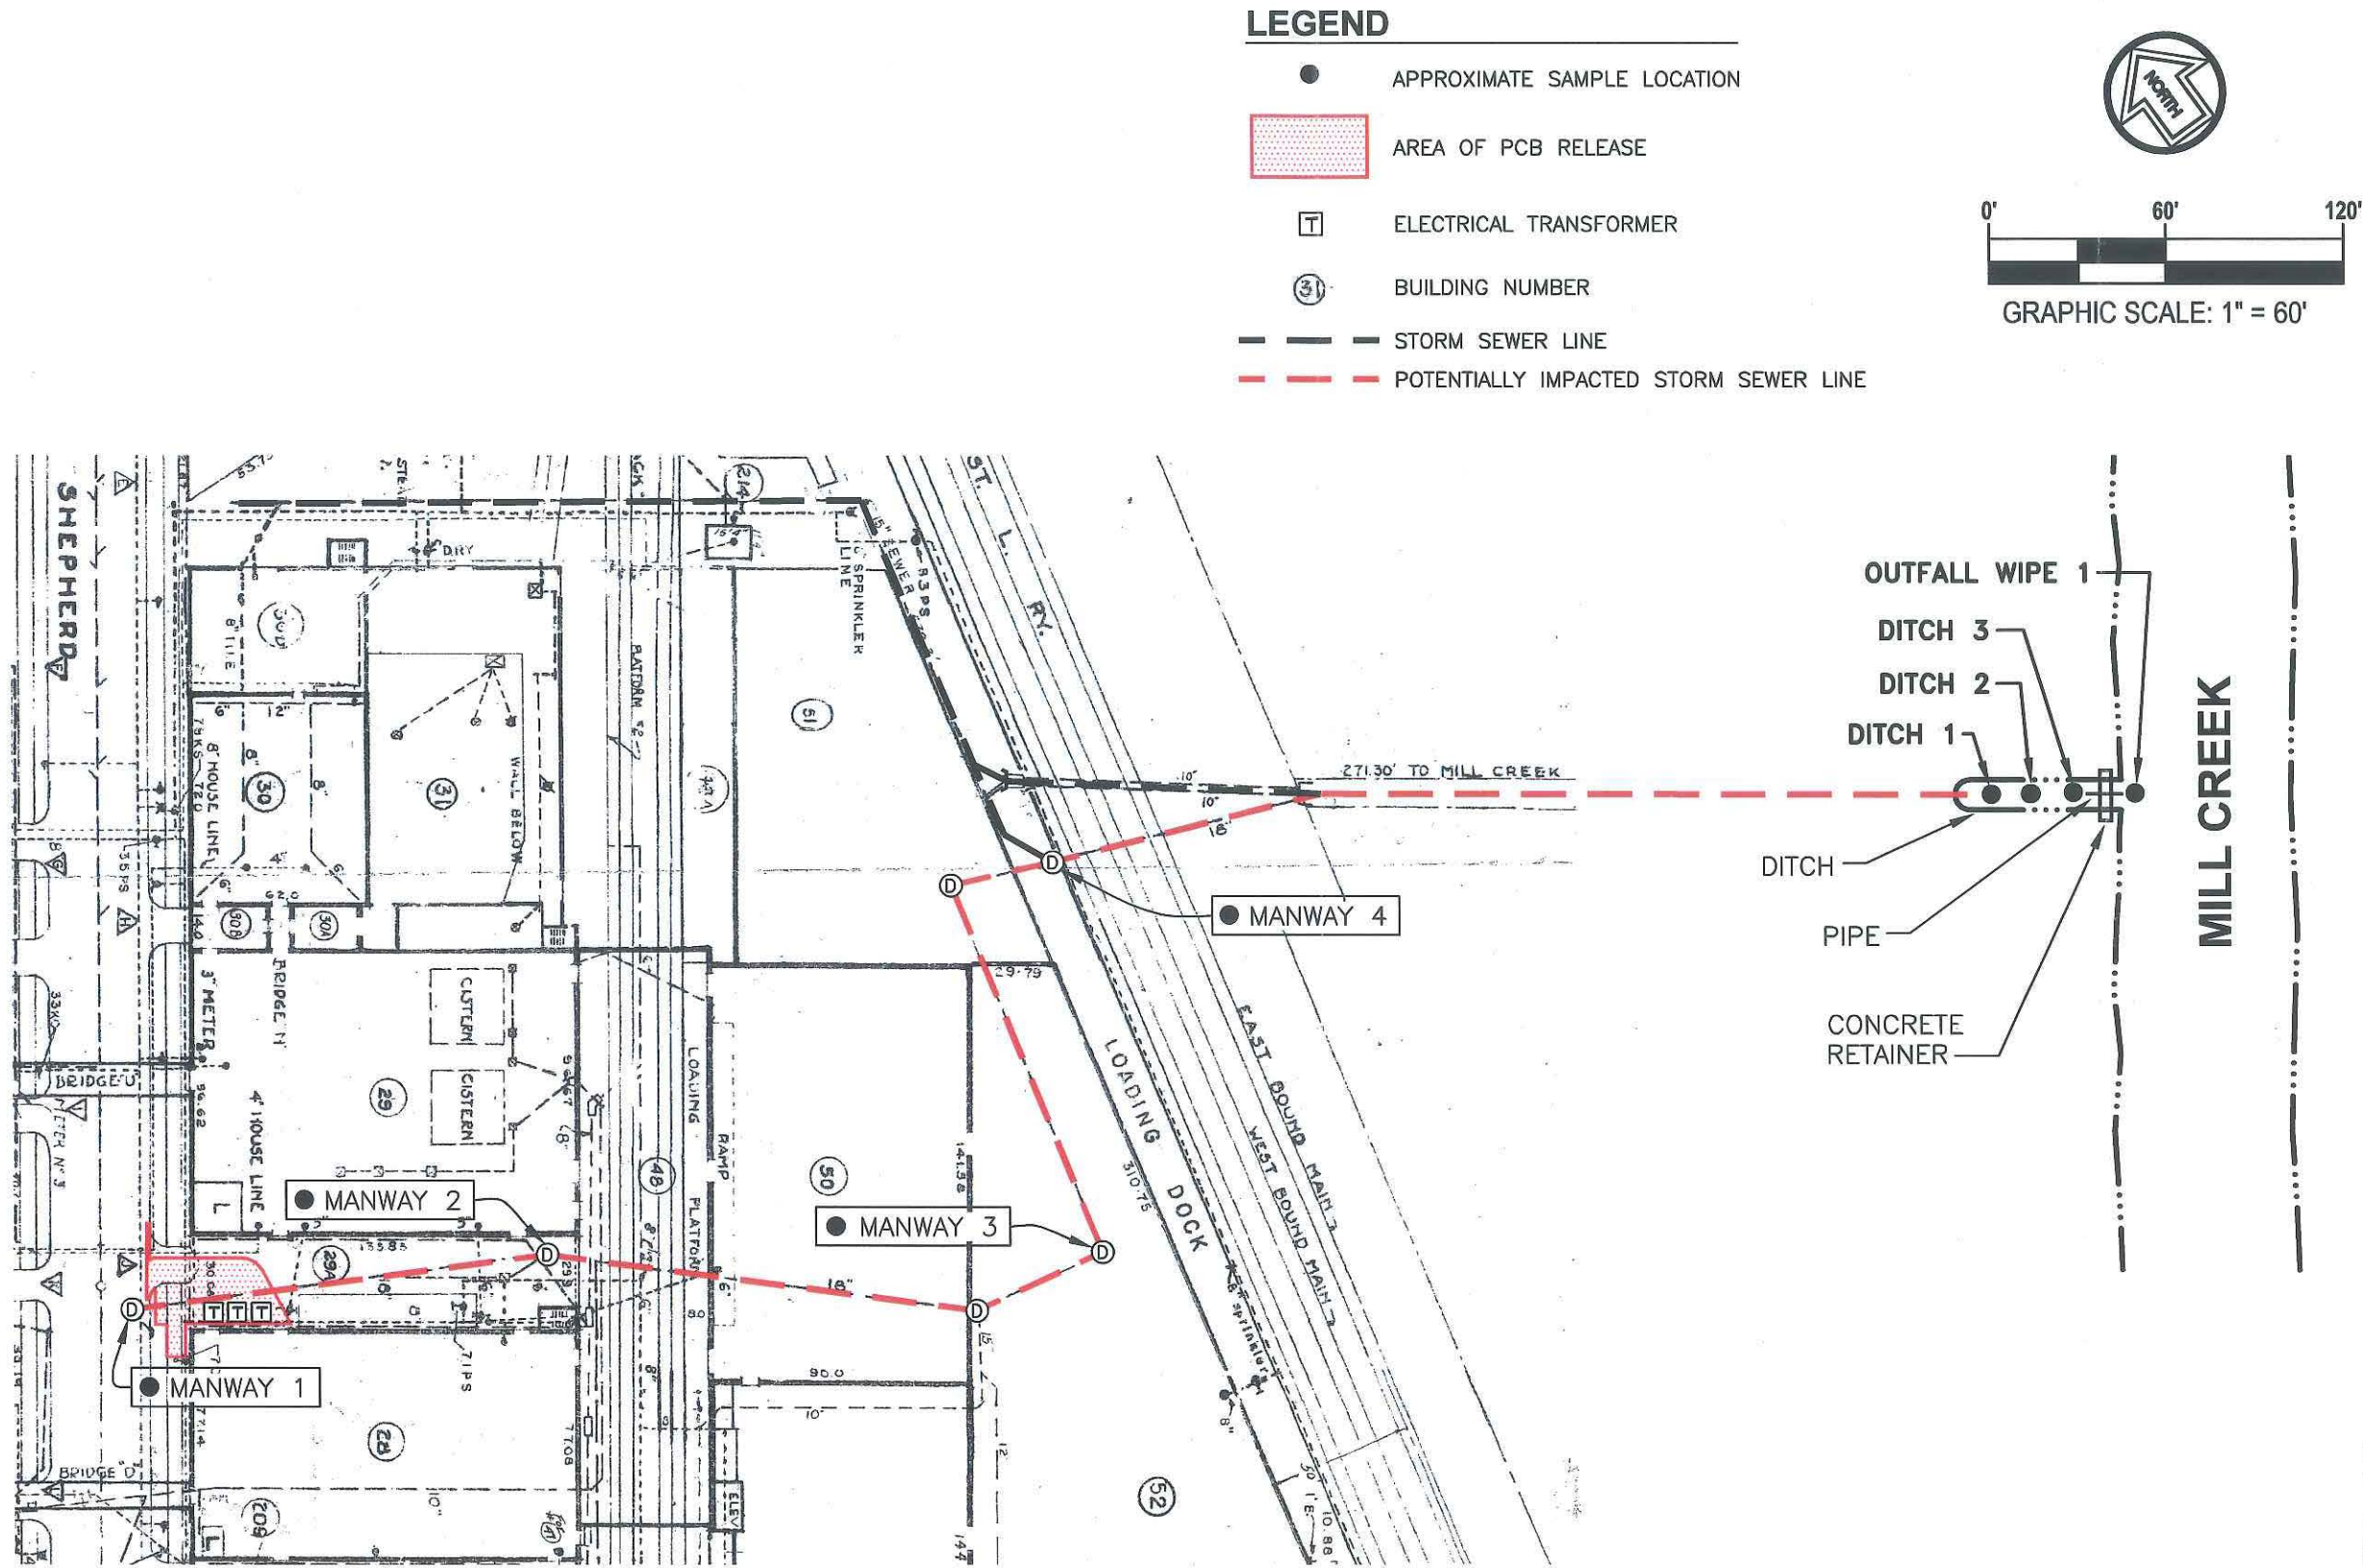
Figure No. 3

*Figure 3 – Storm Sewer Sample Locations*

Subsequent to the release on August 31, 2011, SME collected wipe samples of four manholes (Figure 3). The samples were from the manhole in Shepherd Avenue and three of the manholes along the storm sewer running from the Shepherd Avenue manhole to the Mill Creek. A wipe sample of the outfall was also collected. Due to access and time restrictions, the wipe samples were not collected using a sampling template, but the sample area was approximately 100 cm<sup>2</sup>. The wipe results are presented in Table 1; each wipe contained low levels of PCBs. Figure 4 depicts additional information on the storm sewer including the results of a video survey discussed in Sections 2.3.3 and 5.0. SME also collected three soil samples (Drive 1, Drive 2, and Sidewalk 1) from the bottom of the soil excavation between the metal gate and Sheppard Avenue to confirm all PCB impact had been removed. Figure 5 shows the sample locations. The results were in excess of Ohio VAP commercial/industrial direct contact standards (18 mg/kg). As such, additional excavation will be required; this may include the sides which were not sampled.

SME decided to define the extent of PCB impact using methods consistent with the Ohio VAP in addition to remedial confirmation sampling conducted in accordance with TSCA. The soil in the area around the release area was sampled (PC1 through PC19) as well as the visually impacted concrete curbing (wipe samples W1 through W8). The results are presented in Table 2 while the sample locations are shown on Figure 3.

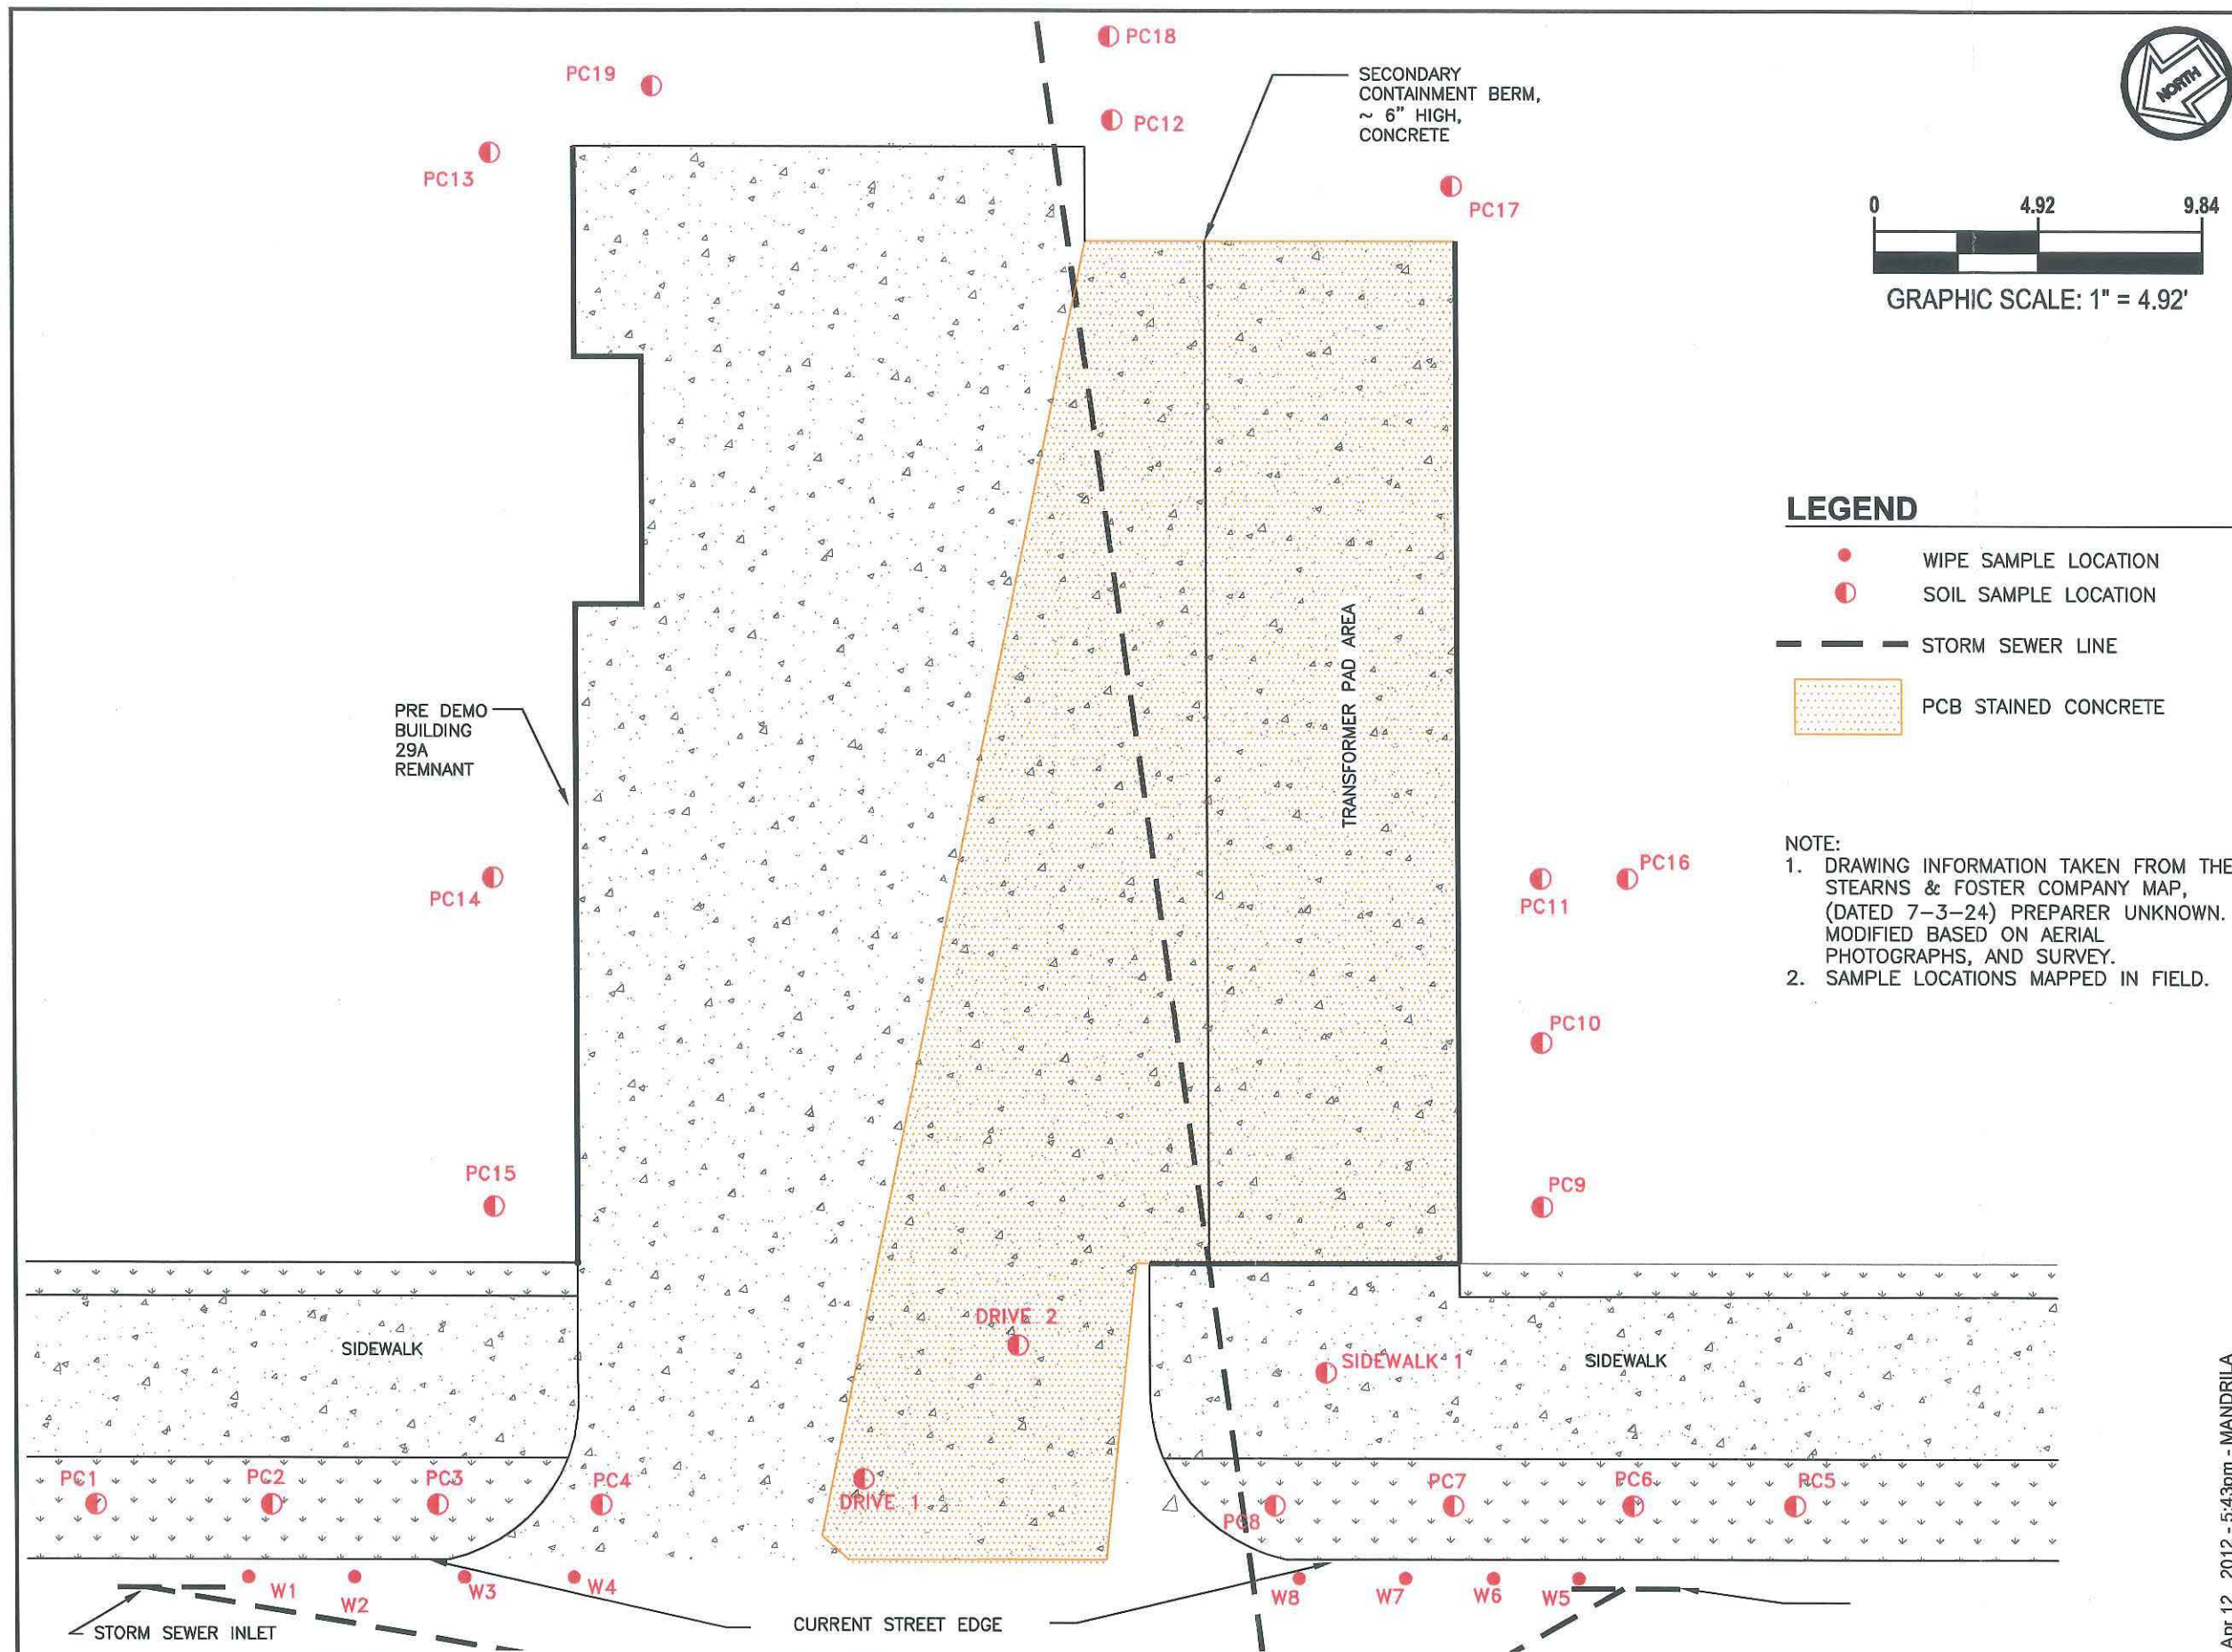
Figure No. 5

**SME PHASE II PCB SAMPLE LOCATIONS**  
**FORMER STERNS & FOSTER PROPERTY**  
**200 SHEPHERD AVENUE**  
**LOCKLAND, OHIO**

Confirmation soil samples were collected using a grid-based sampling approach in accordance with TSCA requirements and the excavation area and sample locations are shown on Figure 5.

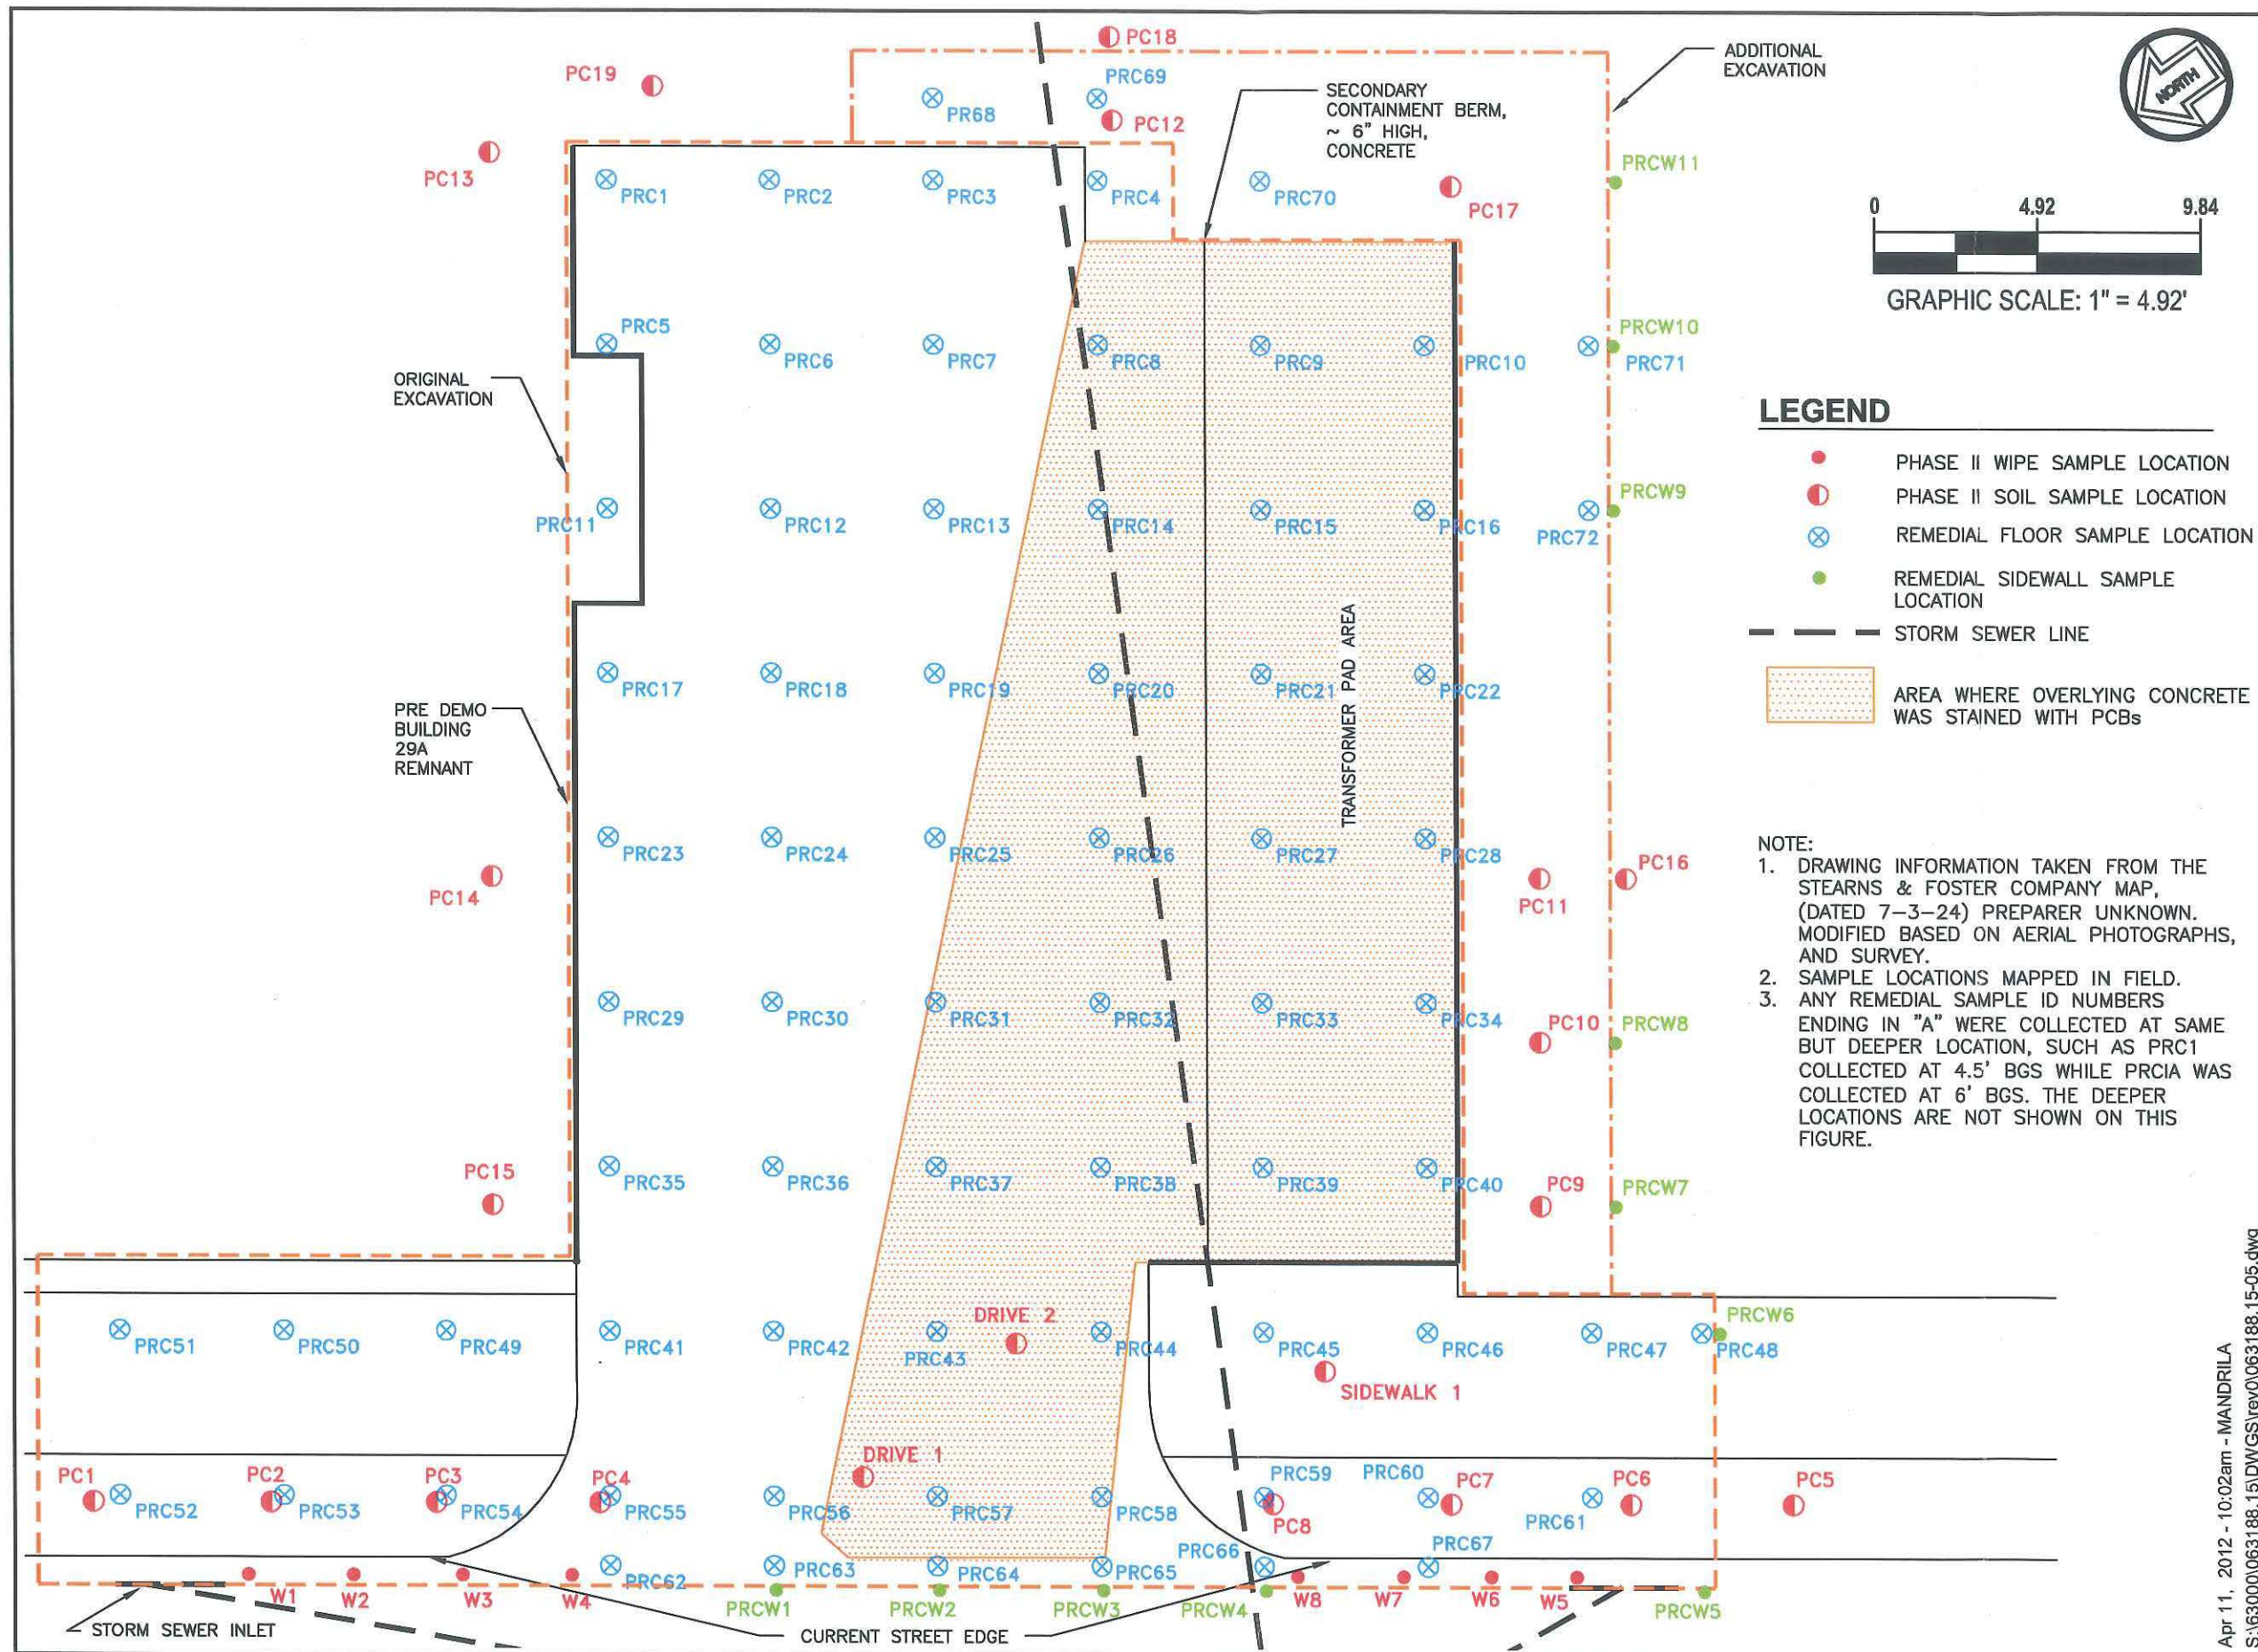
Figure No. 6

*Figure 6 – PCB Remedial Area*

Excavation and loading of PCB impacted concrete and soil in the PCB release area was performed between January 2<sup>nd</sup> and February 28<sup>th</sup> 2012. The areas to be excavated were determined by the Phase II soil sample results, the boundary of the release area based on the foundations, as well as visually during excavation. Figure 5 provides the pre-remedial soil sample locations. The building (former) that housed the transformers was supported by subsurface foundations to the east, south, and north. During excavation of soil within (between) these foundations, it was evident that subsurface transformer oil migration was bounded by the interior portion of the foundation walls. Along the south and east walls, which adjoined the transformers within one foot, some oil migrated down the exterior portion of the foundation walls prior to contacting soil. This necessitated the additional excavation efforts in these directions.
